RE: June 2005 Monthly Report
1.5 Mile Reach Removal Action
GE-Pittsfield/Housatonic River Site

**GE-Pittsfield/Housatonic River Project 1.5 Mile Removal Action
Pittsfield, MA**

Figure 1
1.5 Mile Removal Action
Site Map (Map 1 of 2)
June 2005 Monthly Report

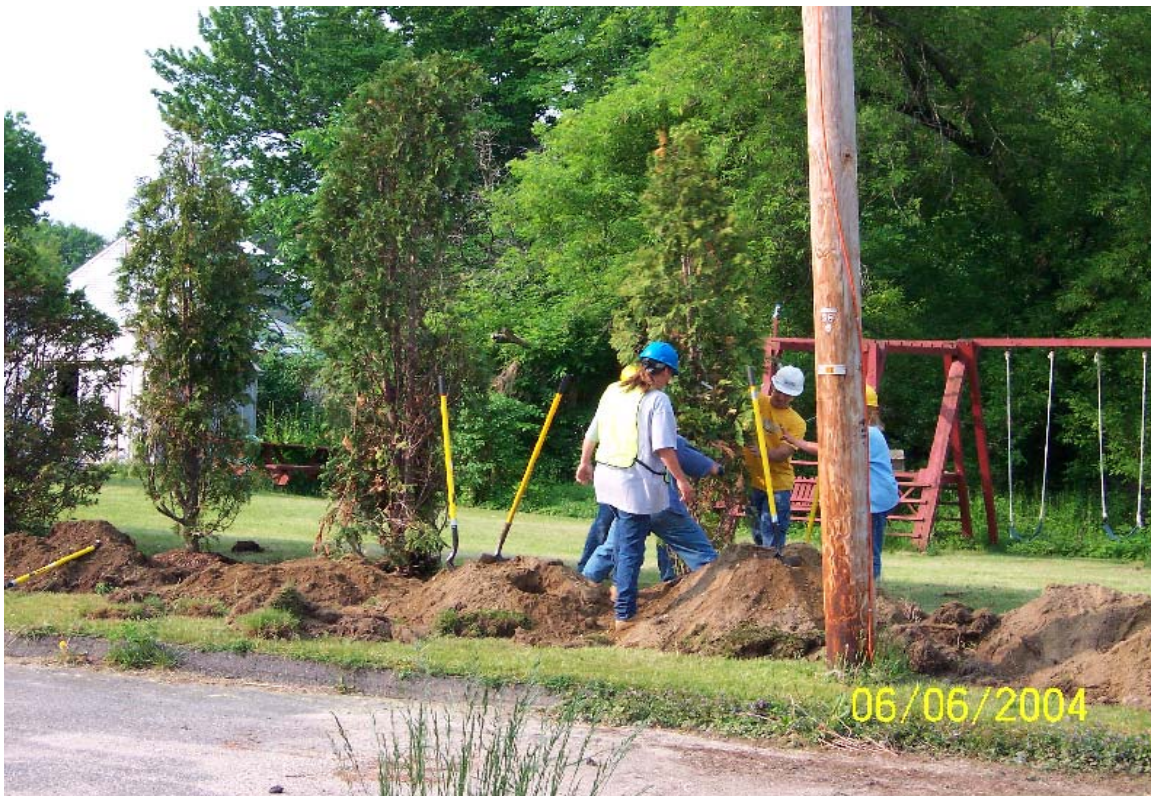
Photograph 1 – Tree Planting Activities on Parcel I9-5-13

The activities associated with the spring planting continued. The installation of five fifteen-foot arborvitaes on Parcel I9-5-13 was completed. These were replacements for previously planted arborvitaes that did not survive. In addition, the installation of four four-foot spruce trees along

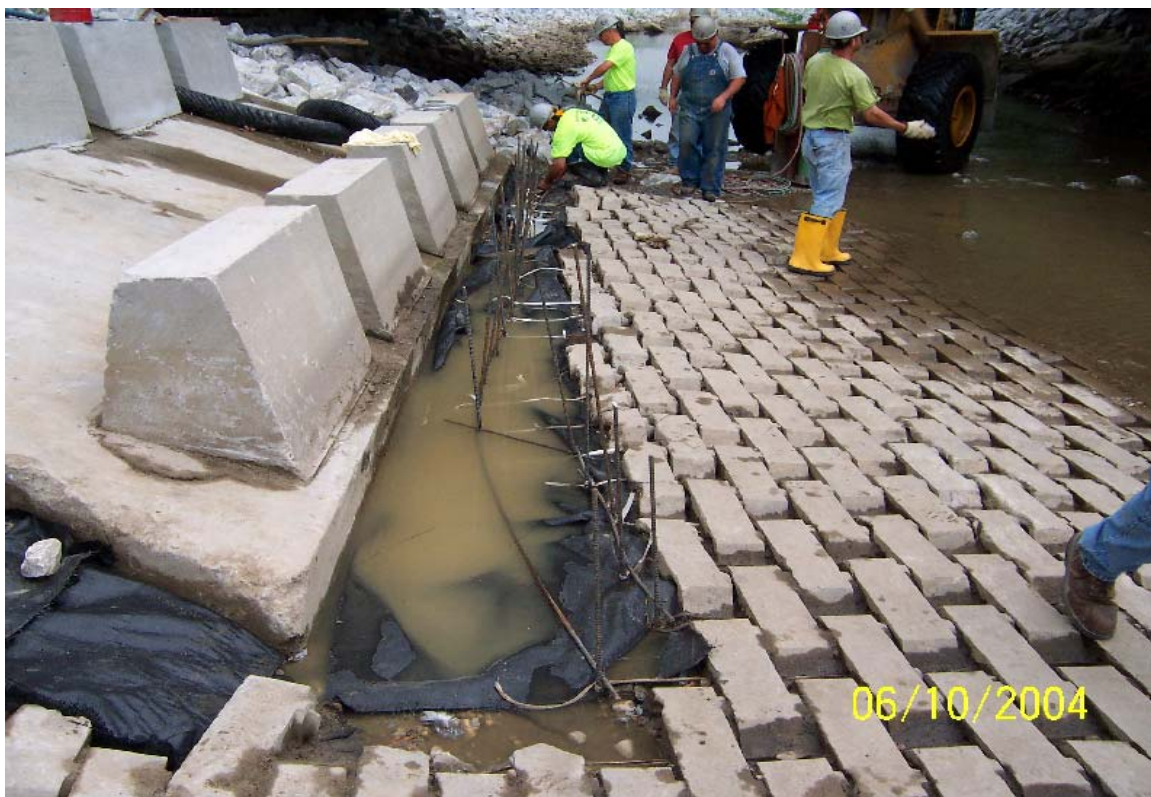
Photograph 2 – Elm Street Dissipater Restoration Activities- Placement of Re-bar

Also, during the first week of June, activities associated with completing the restoration of the energy dissipater at the outfall pipes at the Elm Street Bridge were initiated. The bin blocks and steel plates that were previously installed as an erosion control measure were removed. The articulated concrete block (ACB) located on the riverbank upstream of the energy dissipater as well as a portion of the ACB located on the upper riverbank downstream of the energy dissipater was also removed. The area adjacent to the energy dissipater located in the riverbed and part way up the riverbank on the downstream end of the energy dissipater was excavated down approximately one foot. Geotextile was placed at the based of this excavation and up the riverbank. Re-bar was then placed in this area into the sediment. The Polyethylene (PET) cables from the ACB in the riverbed were tied to the re-bar and grout was placed to tie-in the energy dissipater to the ACB. The grout was also extended into the void spaces in the ACB approximately five feet into the riverbed. Lastly, riprap was placed on the riverbank upstream and downstream of the energy dissipater, tying into the dissipater and to the grout.

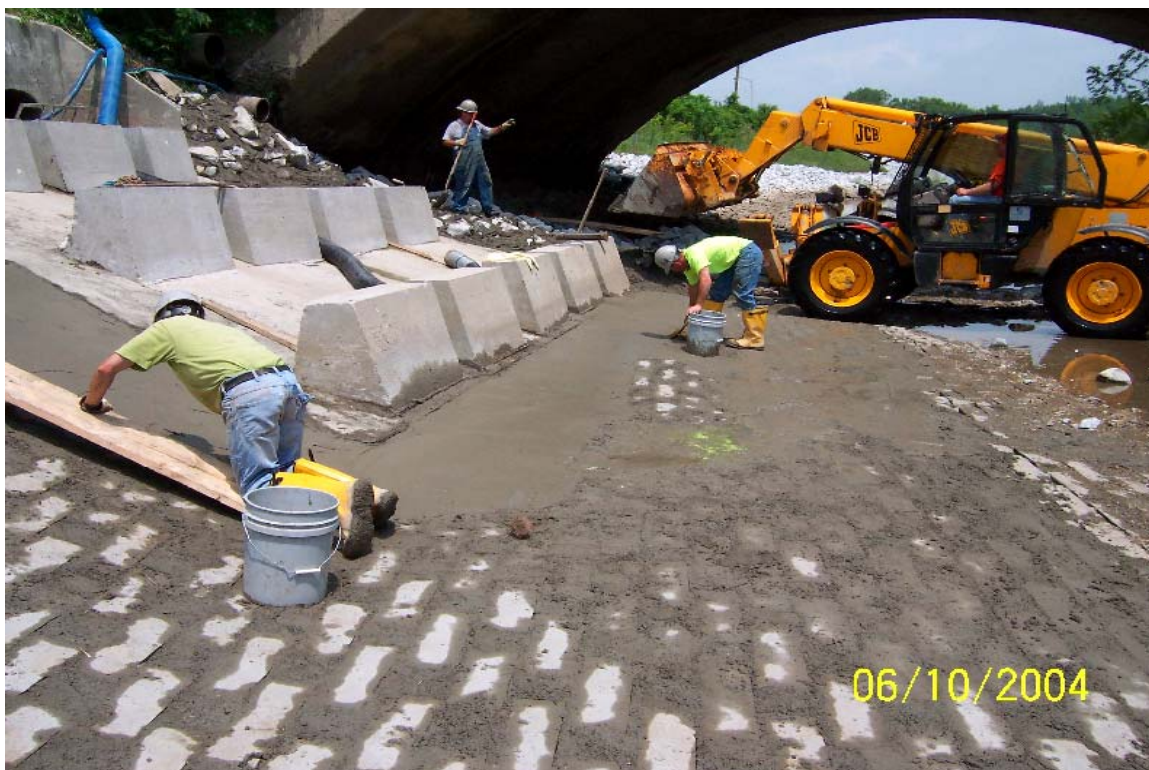
Photograph 3 – Elm Street Dissipater Restoration Activities- Installation of Grout

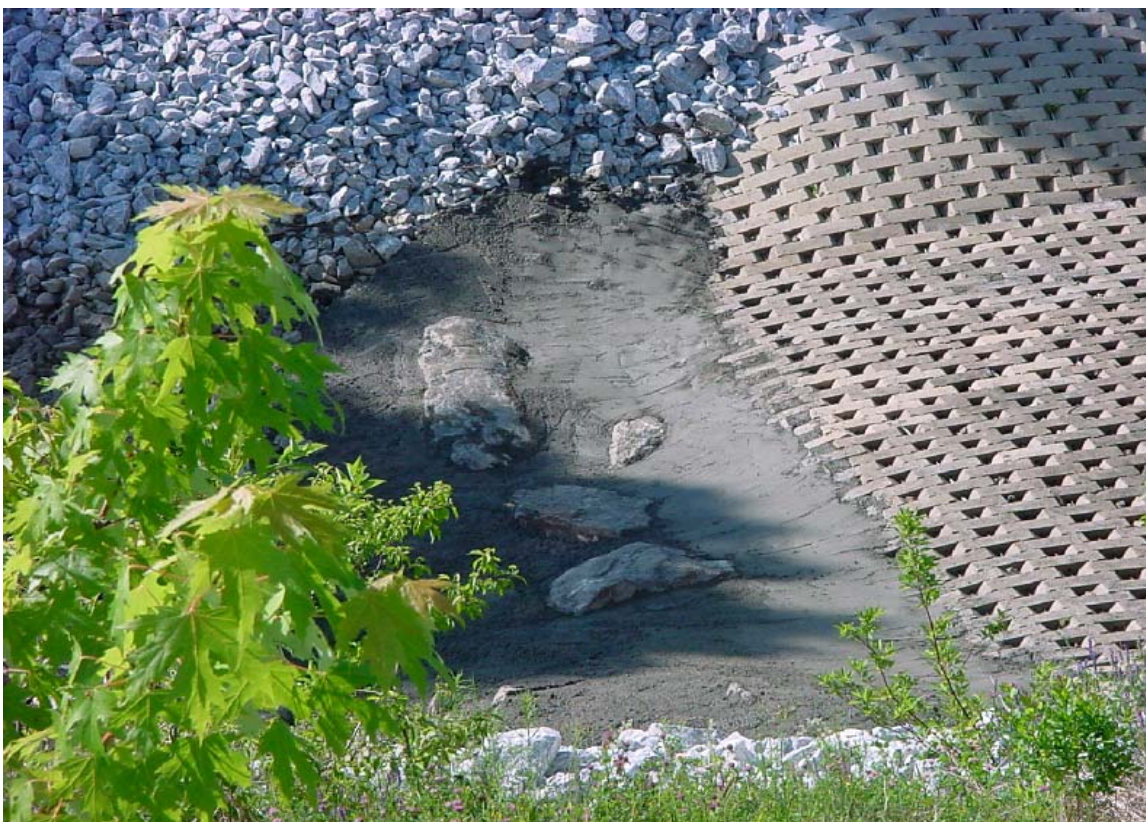
Photograph 4 – Tie-in of Downstream End of ACB to Riprap/River Bottom with Grout

Also during the fourth week of June, grout was placed at the downstream end of the ACB to minimize the potential for erosion at the ACB and the restored riverbed interface. In addition, three boulders were placed at the end of the ACB to dissipate some of the energy associated with the flow over the ACB. One additional aquatic enhancement boulder was placed on the ACB. Lastly, the riprap underneath the Elm Street Bridge down to the upstream interface with the energy dissipater associated with the outfall pipes located immediately downstream of the Elm Street Bridge was regarded to create a smooth transition between the riprap and energy dissipater. The area was accessed by adding stop logs to the temporary dam to block the entire river flow. The stop logs were removed at the end of the work day opening up the river channel. This completes all restoration activities associated with the energy dissipater and the ACB.

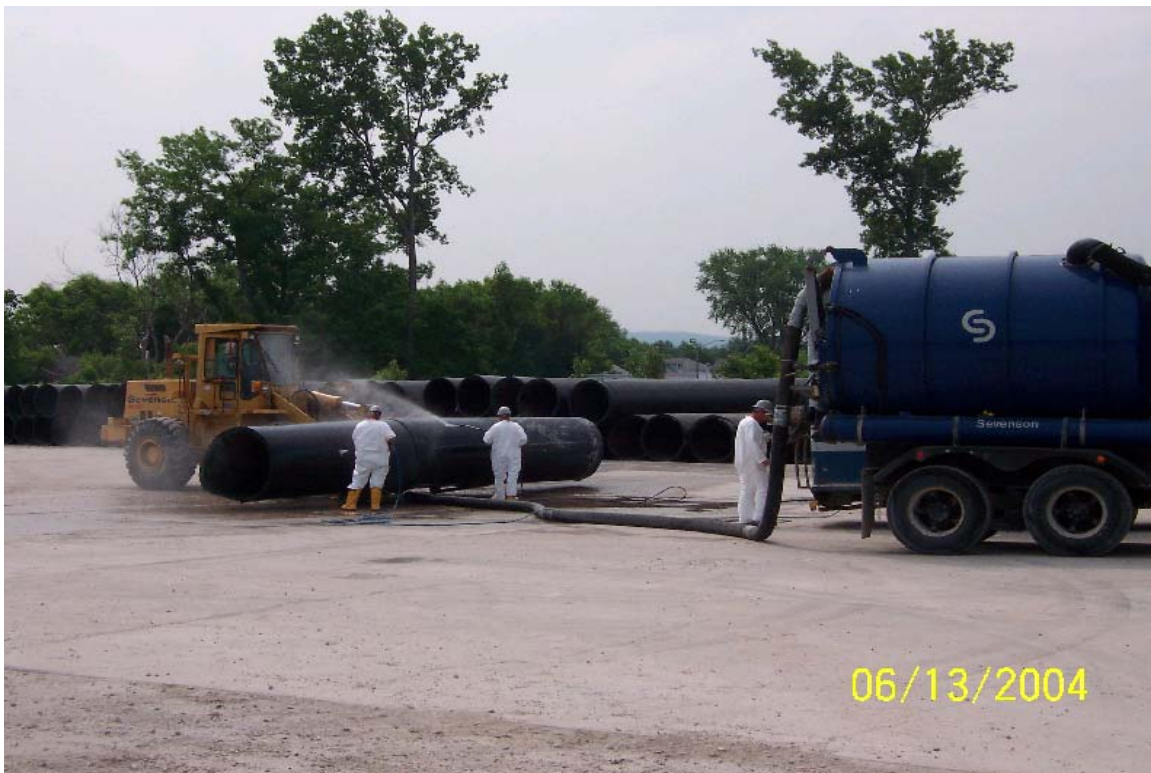
Photograph 5 – Decontamination of the 54-inch HDPE River Diversion Pipe

Activities associated with decontamination of the 54-inch HDPE river diversion pipe were initiated by performing a test round of decontamination procedures. A detailed description of the decontamination procedures can be found in a memorandum dated June 6, 2005 from Weston to USACE and EPA titled "1.5 Mile Removal Action – Cleaning and sampling of 54-inch diameter HDPE pipe prior to off-site recycling".

Activities associated with decontamination of the 54-inch HDPE river diversion pipe were officially started on the sections pipe slated for off-site recycling. Wipe sampling of the decontaminated pipe was also initiated.

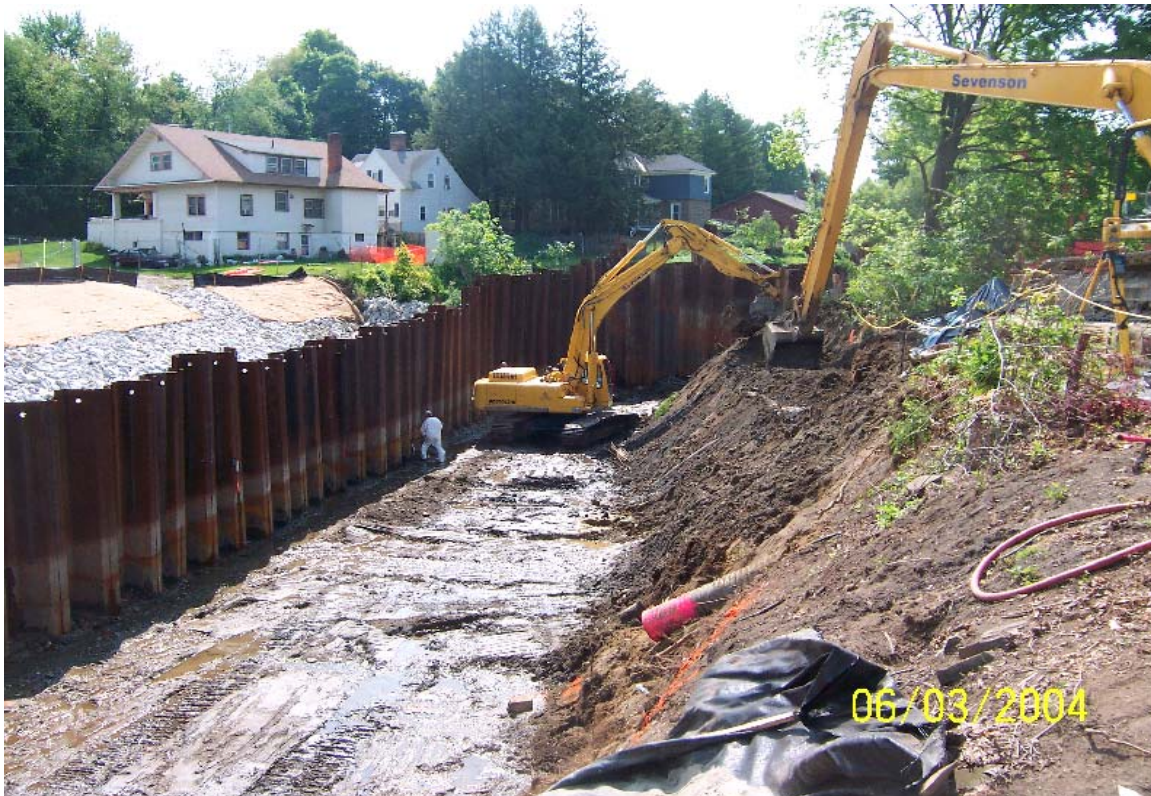
Photograph 6 – Excavation Activities in Cell 27

By the end of May 2005, the installation of the Cell 27 upstream and downstream cutoff walls was initiated. During the first week of June, the installation of the Cell 27 upstream and downstream cutoff walls was completed. Once Cell 27 was isolated, the dewatering activities were initiated by pumping water greater than 6-inches in depth directly back to the river. Once the water depth reached 6-inches, it was pumped to the WTS. Sumps and swales were installed to help in the dewatering process. Once the dewatering was completed, the survey contractor completed the delineation of non-TSCA and TSCA excavation areas in Cell 27 and the excavation activities in Cell 27 were performed. The excavated TSCA material was transported to Area 64A stockpile management area. The non-TSCA material characterized for off-site disposal was transported to Area 64B and the non-TSCA material not characterized for off-site disposal was transported to Area 64C stockpile management areas. (See Table 1 for quantities of material generated in the month of June 2005 and Table 2 for quantities of material generated to date.)

The surveyors monitored the excavation activities in Cell 27 to ensure appropriate design excavation depths were achieved. Once the excavation activities were completed, the final excavation verification survey was performed in Cell 27, staking out of the backfill grades was initiated.

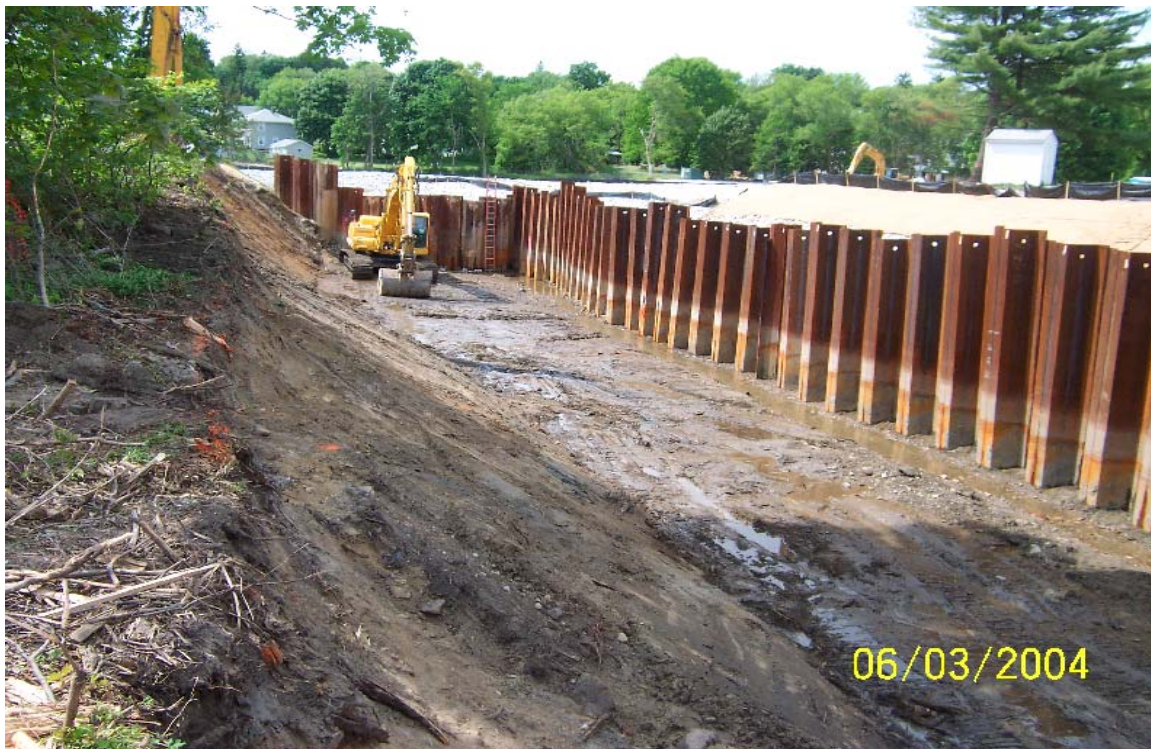
Photograph 7 – Cell 27, Excavation Activities Completed

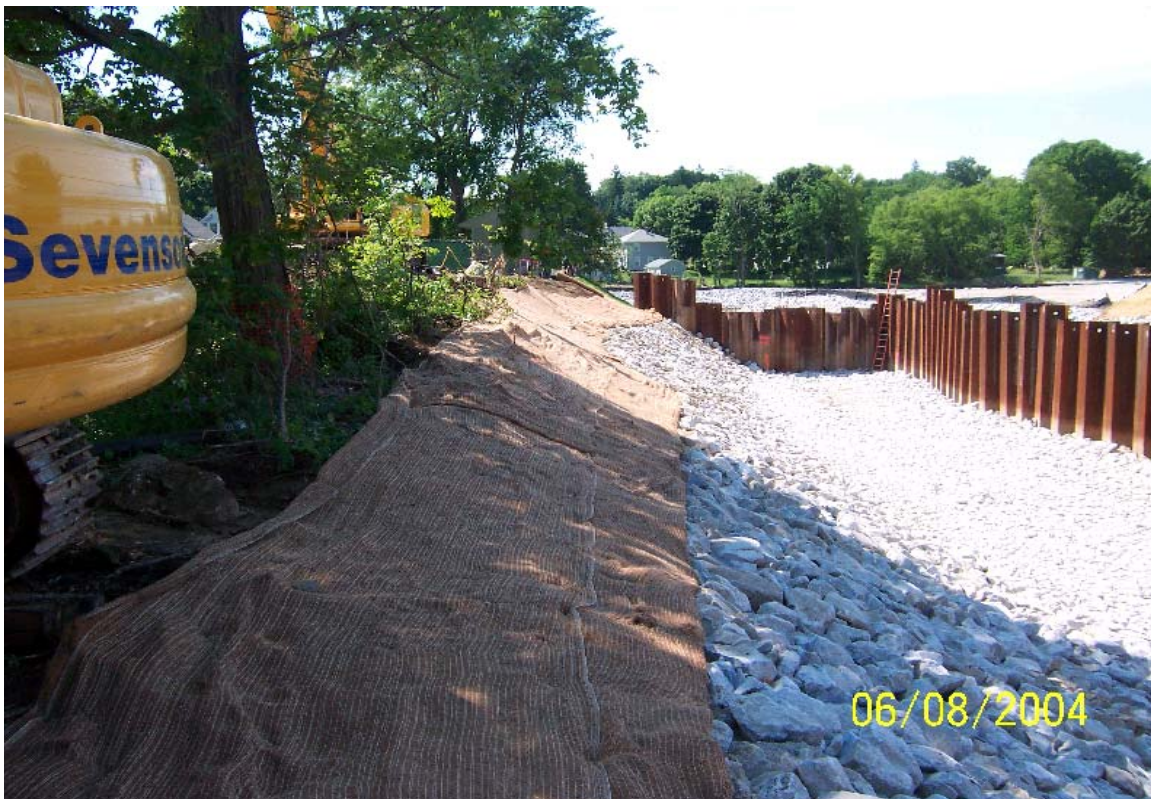
Photograph 8 – Backfilling Activities Complete in Cell 27

The riverbed and riverbank of Cell 27 was backfilled in the following manner: The first 100 feet of the riverbed was backfilled with a layer of common fill to the design grade, followed by a nine-inch layer of filter material Type II, and an eighteen-inch layer of 12-inch riprap. The last 75 feet of the riverbed will be backfilled with a layer of common fill to the design grade, followed by a nine-inch layer of filter material Type II, and a fifteen-inch layer of 9-inch riprap. The riverbanks will be backfilled with common fill to the design grade, a nine-inch layer of filter material Type II and a twenty four-inch layer of 18-inch riprap up to elevation 967.5 feet above mean sea level (AMSL).

In areas where the riverbank extends above elevation 967.5 feet AMSL, the riverbank will be backfilled as follows: Common fill will be installed in twelve inch horizontal lifts and compacted to meet the 95% compaction requirement. Then, a minimum six-inch layer of topsoil, herbaceous seed mix and erosion control blankets will be installed.

The surveyors monitored the backfilling activities in Cell 27 to ensure appropriate design backfill grades were achieved. Once the backfilling activities were completed the final restoration verification survey was performed.
